DB15
CAT1 Expert 2K

"Y" CABLE

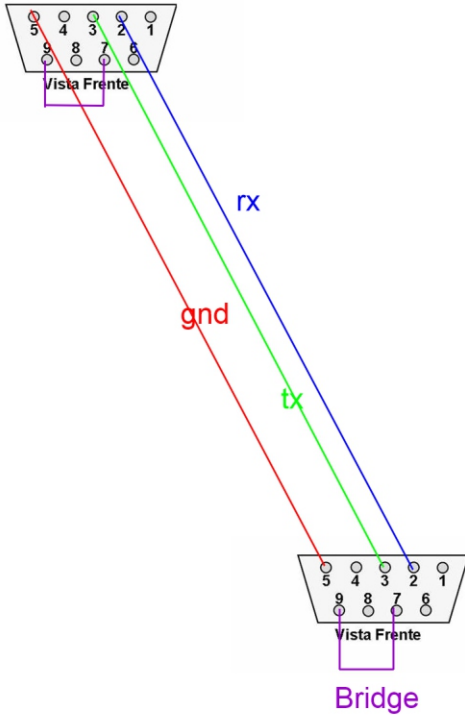
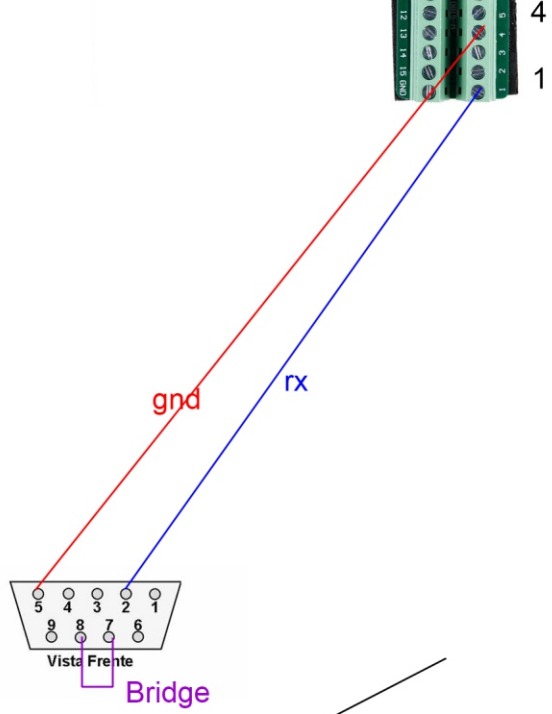
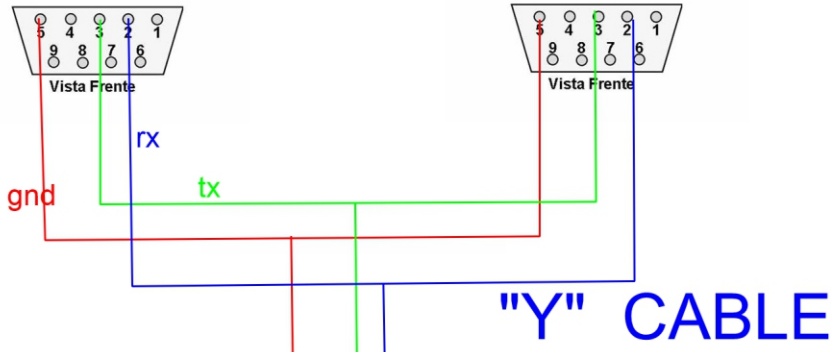
Please double check the PIN number , depending if is male or female , rear view or front view can cause a lot of troubles.

DATA In STEPPIR

TS-990 REAR
